Geochemical Characterization of Chromate Contamination in the 100 Area Vadose Zone at the Hanford Site

PNNL-SA-61819

July 29, 2008

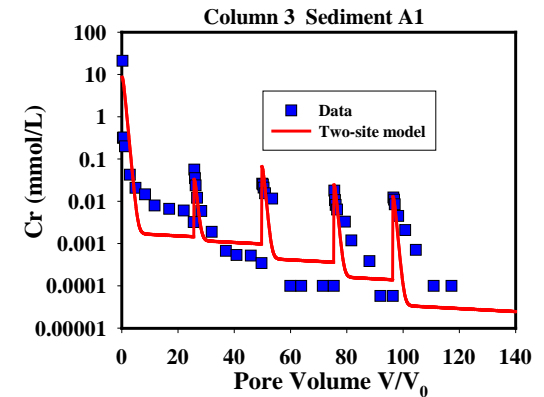
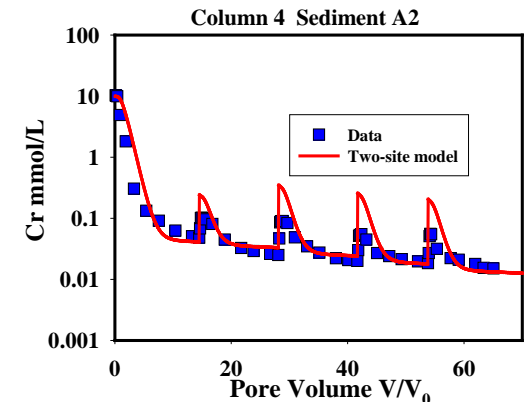
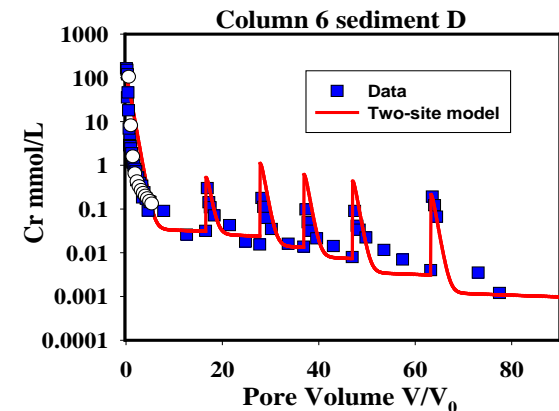
Modeling Results

- ▶ CXTFIT model used to calculate transport parameters base on the bromide breakthrough curves
- ▶ Péclet numbers calculated for experiments were close to 1 indicating mixture of advective and diffusive control on transport
- ▶ Dispersivities < 2 cm were typical for laboratory columns
- ▶ Cr(VI) desorption fit to 2 site model
- ▶ Equilibrium K_D values were close to 0, as expected
- ▶ 95-99% of Cr(VI) in sediments was associated with the equilibrium release fraction
- ▶ Small fraction with time-dependent desorption released with half-lives of 76 – 126 hr.

- ▶ Leaching behavior could be adequately described by a 2-site sorption model with one “site” showing essentially no retardation
- ▶ Tailing of Cr(VI) release was greatest in area of co-disposed Cr(VI) and sulfuric acid. The cause of the longer tailing was not apparent in these samples.

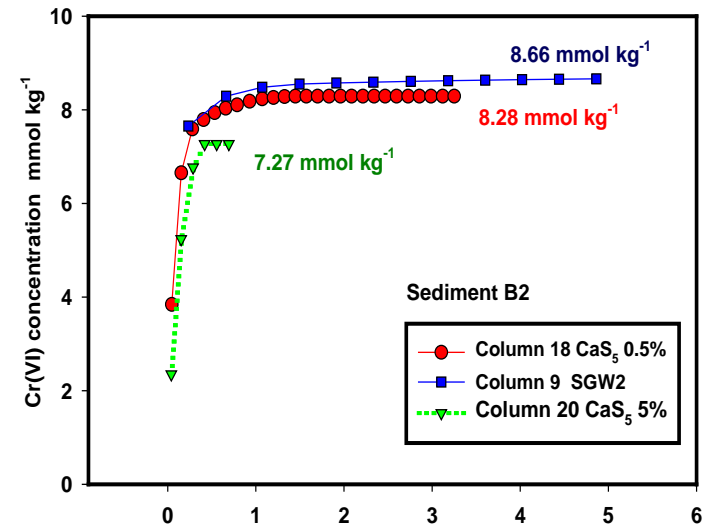
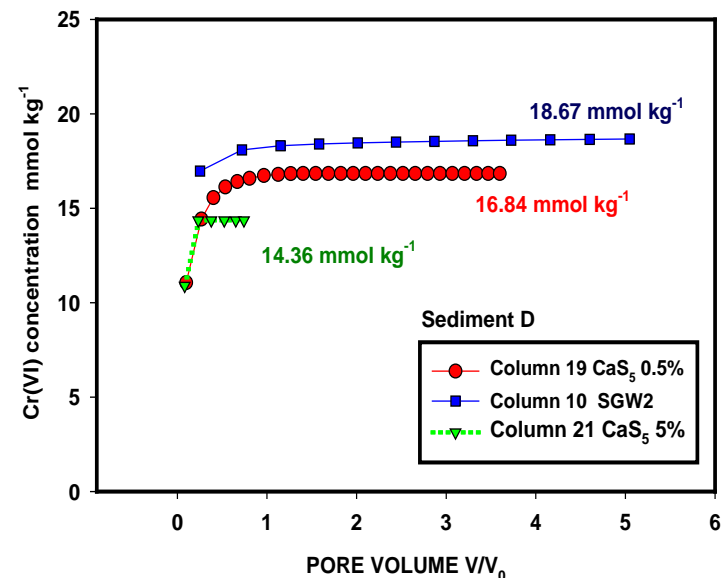
Contaminated Sediment Reaction with Calcium Polysulfide

- ▶ Sediments packed in columns leached from the bottom up with calcium polysulfide solutions
- ▶ Fluid residence time ~ 2 hr
- ▶ Polysulfide decreased the total amount of Cr(VI) leached but majority of the Cr(VI) was still mobilized in the first pore volume
- ▶ Cr(VI) mobilization at reaction front is an issue that must be considered for remedial schemes using liquid reductants

- ▶ Liquid reductant mobilized Cr(VI) at solution front so effectiveness for remediation was limited
 - Both physical and chemical processes need to be understood for remedial design

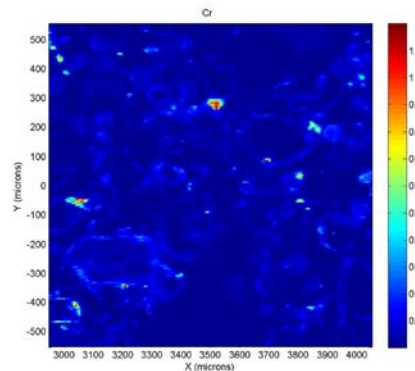
Location A2
Old Spill

- ▶ Thin sections of sediments analyzed
- ▶ Area imaged in 10 μm steps to determine relative concentrations of chromium (and other elements) in sediments
- ▶ Detection limit $\sim 1 \mu\text{g/g}$
- ▶ XANES spectra collected on selected spots
- ▶ Chromium detectable in all samples as grain coatings and discrete grains

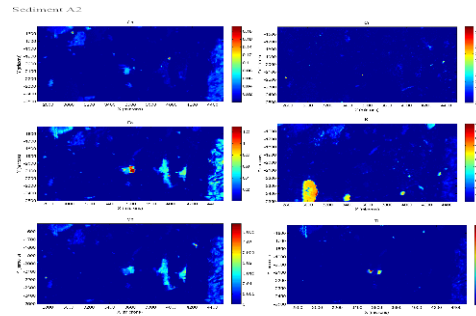
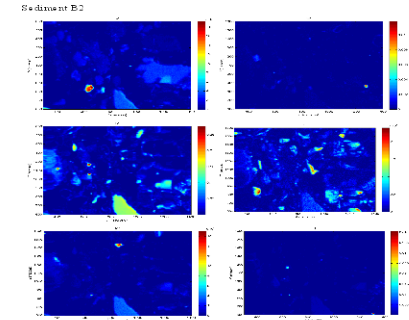
Location A2
Old Spill

- ▶ Sediments leached with 5 pore volumes of chromium-free synthetic groundwater to remove weakly bound Cr(VI)
- ▶ Leached sediments showed only a weak chromium signal indicating a lack of low mobility chromium phases

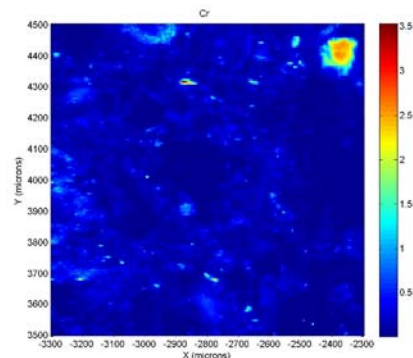
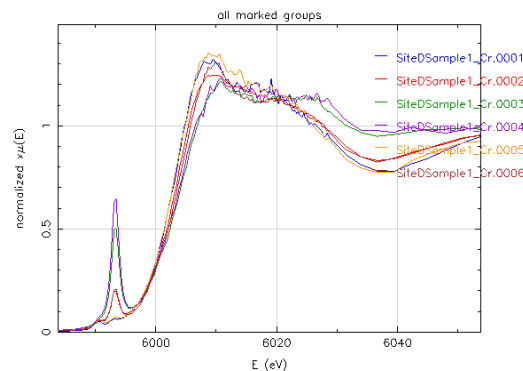
Location D
Recent Spill

- ▶ Reduced chromium observed in small concentrated zones within grain coatings
- ▶ Variable Cr(VI):Cr(III) seen at Location A, B, and D
- ▶ Only Cr(III) seen after leaching
- ▶ Sediment 71-1 – only Cr(III) detected

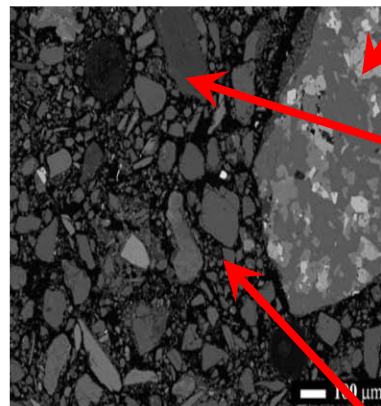
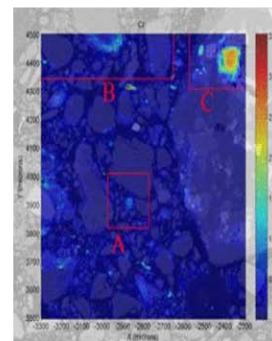
Fe map

- ▶ Chromium not detected with EDS
- ▶ XMP maps used to locate area of elevated chromium for SEM examination
- ▶ Elevated chromium associated with secondary mineral phases and clay inclusions
- ▶ May host leaching resistant fraction in pores isolated from advective flow

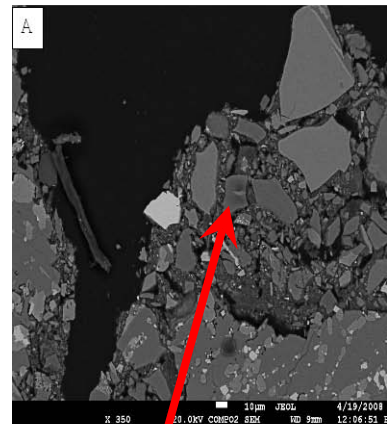
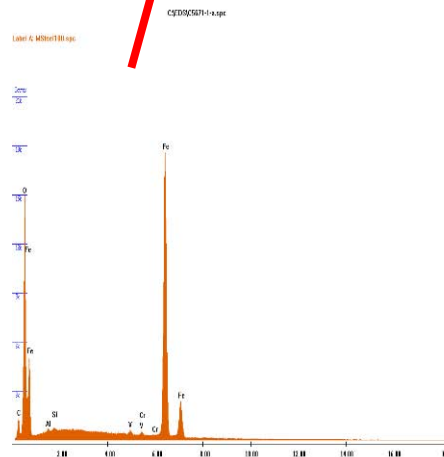
Iron oxide containing chromium

- ▶ Deeper borehole sample 71-1 showed chromium associated with minor phases
- ▶ One particle associated with iron oxide (likely magnetite)
- ▶ One particle identified as barium chromate

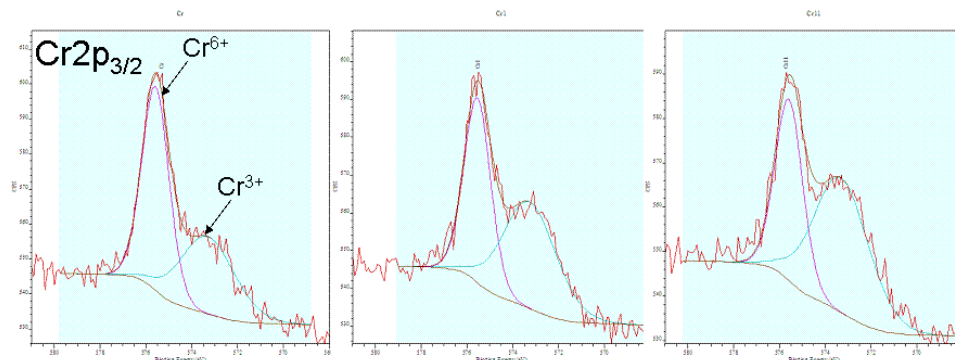
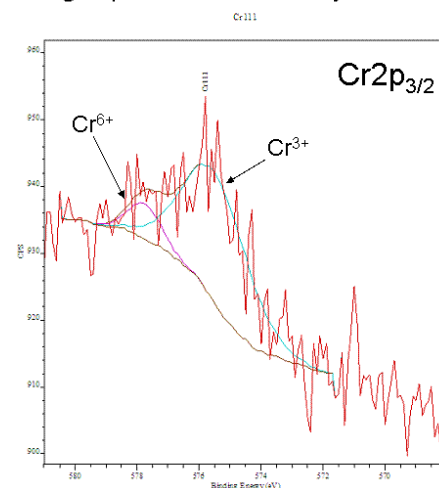
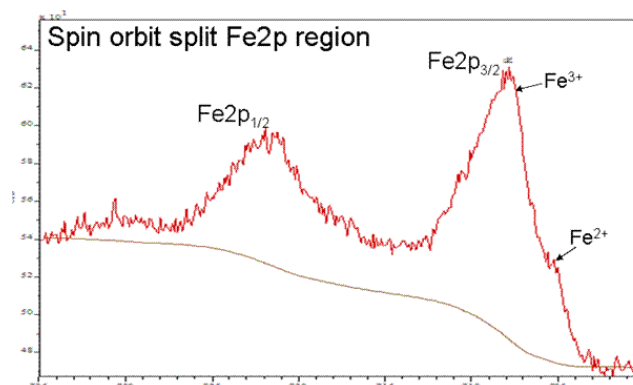
XPS

- ▶ Majority of chromium in unreacted samples present as Cr(VI) with a small fraction of Cr(III) from reduction at surfaces
- ▶ Reduction of Cr(VI) occurred in beam so initial Cr(III):Cr(VI) ratio was estimated from Cr(VI) in unleached samples and Cr(III) in leached samples
- ▶ Surface iron present as mixed Fe(II)/Fe(III) indicating possible mechanism for the limited chromium reduction

Increasing exposure time to X-ray beam →
